Science and Restoration of SAV in the Hudson River Estuary

**NYS Department of Environmental Conservation
Hudson River National Estuarine Research Reserve**

**NYS Department of Environmental
Conservation in coordination with the Water
Resources Institute at Cornell University**

October 23, 2025

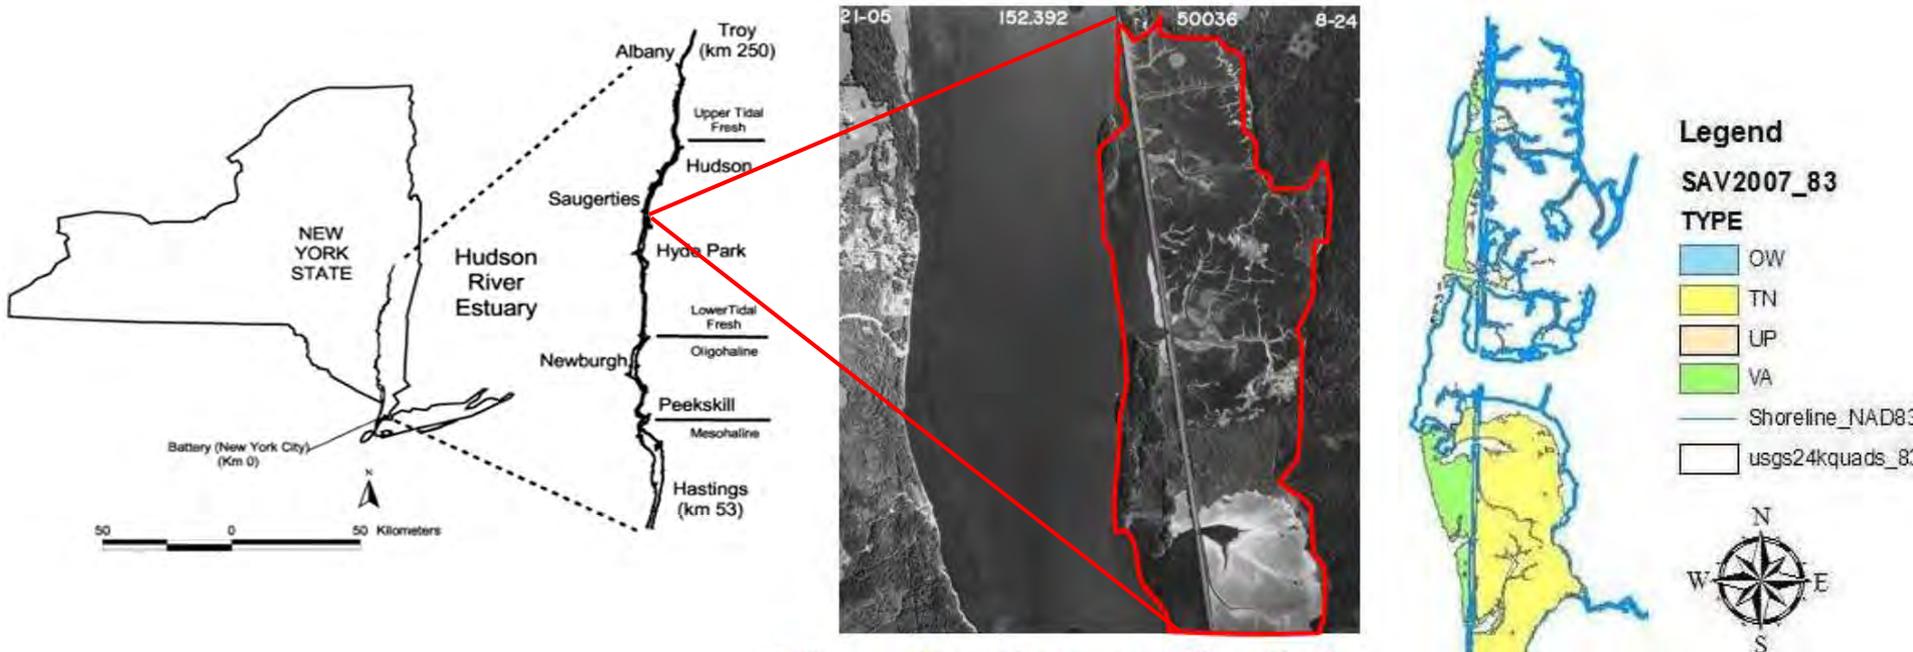
River Section at Tivoli Bays

Submerged Aquatic Vegetation Mapping

There are over 1,400 acres less SAV habitat today than 25 years ago

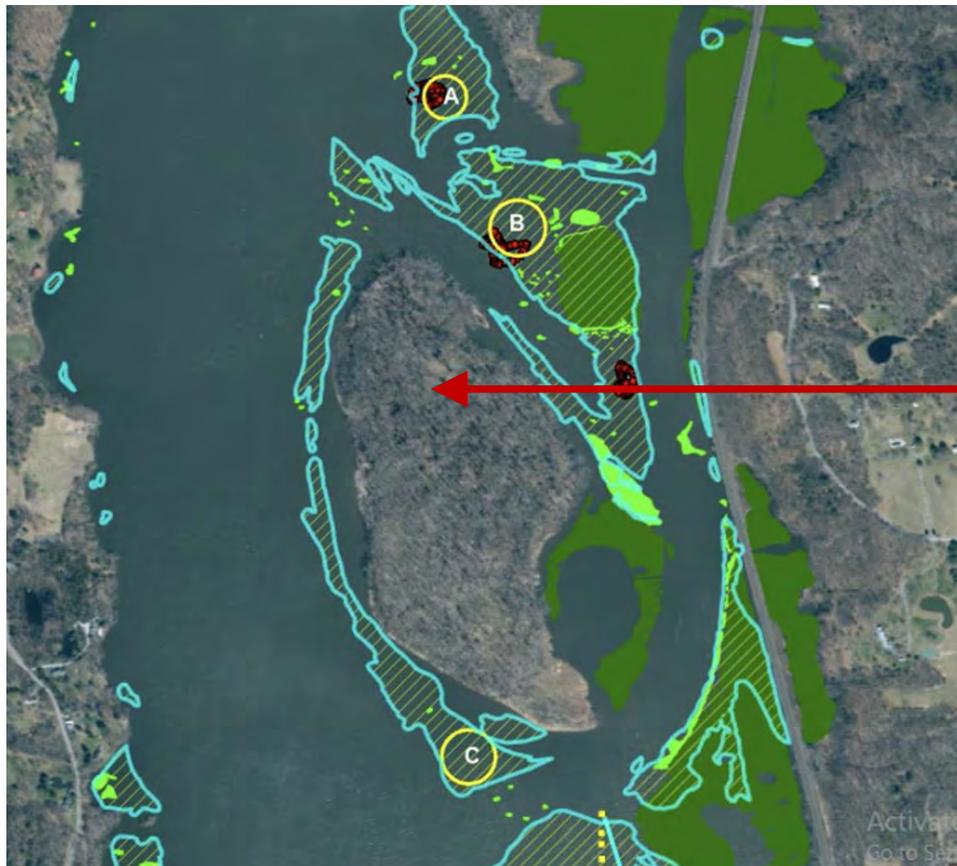
Stockport Flats: SAV Planting Study

Site selection rationale

- Where SAV has grown before
- Where there was no natural SAV in 2022
- Where Trapa did not replace SAV in 2022

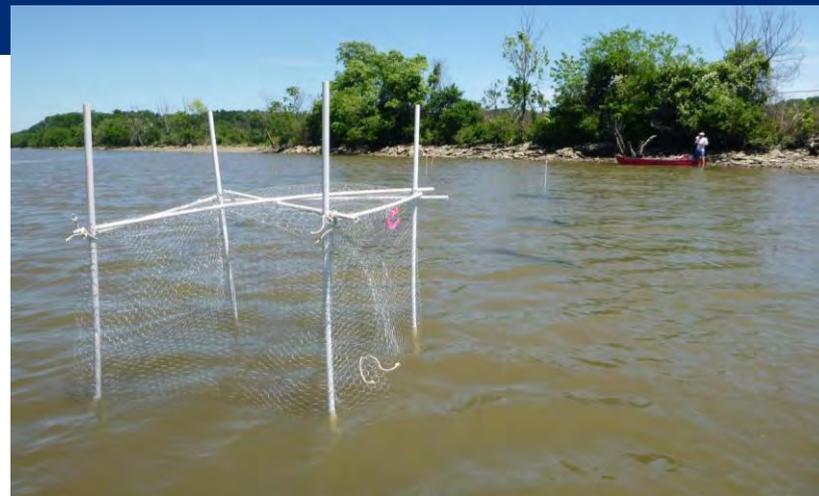
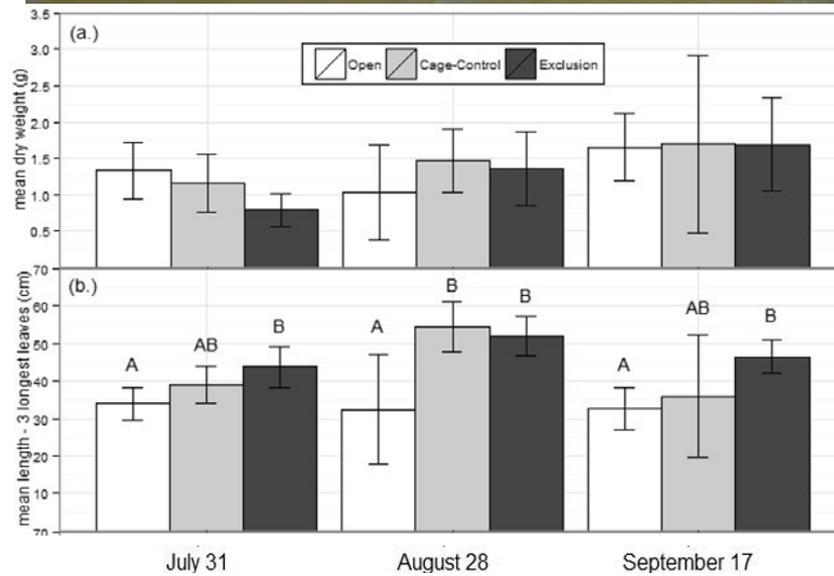
Herbivory pressure was tested in the Hudson River using an exclusion cage experiment with controls. No significant difference in growth was found between treatments.

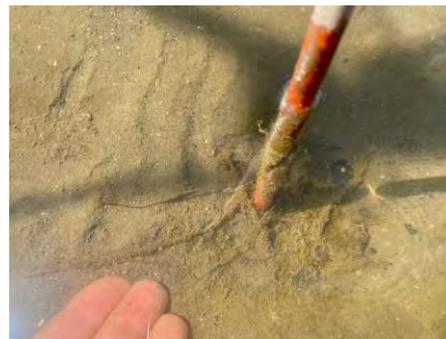
~75% no growth

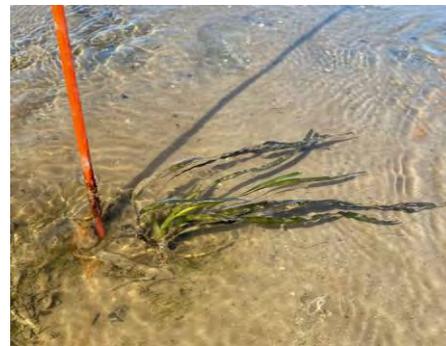
~25% sparse growth

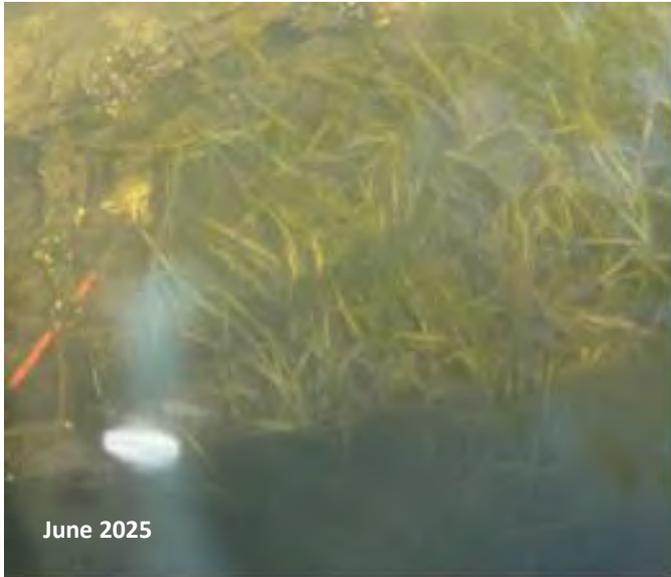
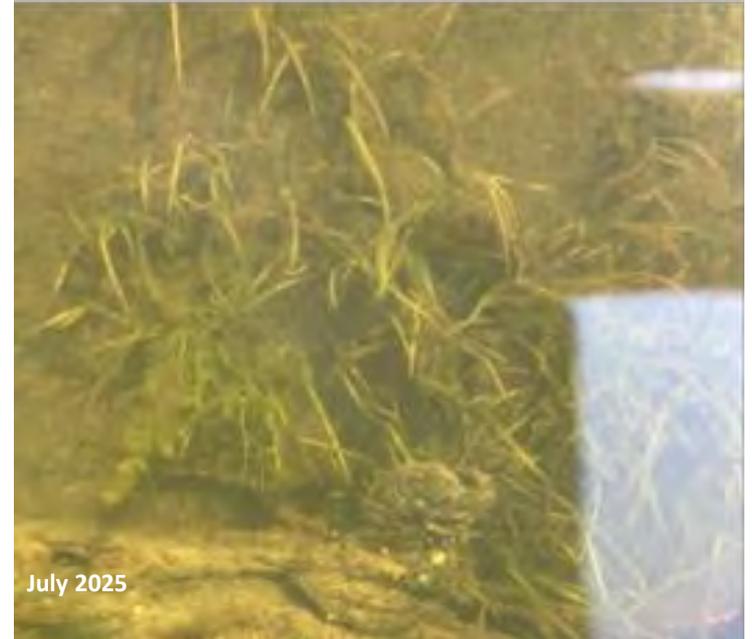
2025 Restoration Effort

- Plants in river island area (exposed to low sedimentation) survived and came back in 2025, plants in lower river were buried by sediment and could not establish in 2025.

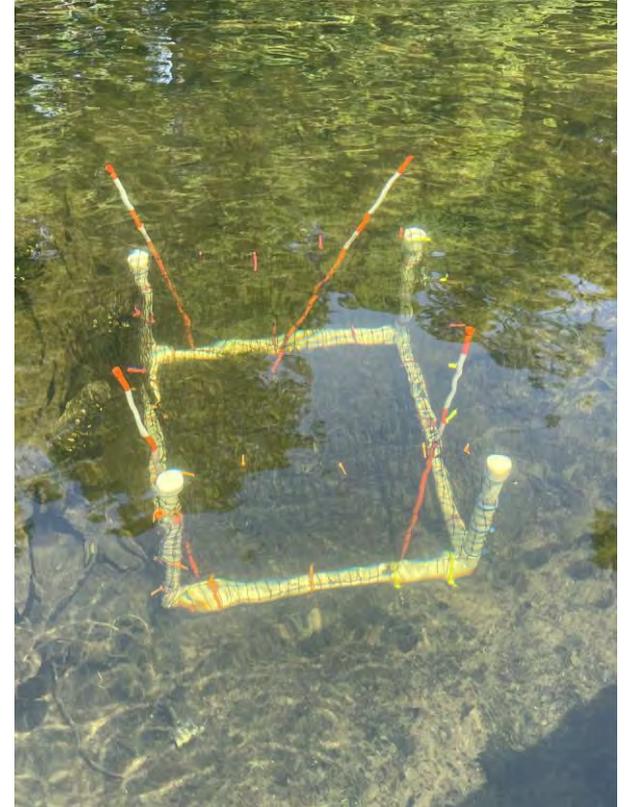
Restoration Methods 2025

- Methods from 2024 were repeated with focus on areas of high potential success (areas of low sedimentation).
- In July, plants from 2024 were checked and new cage was installed
- In August, the plants were staked in the Croton and surrounded by a PVC and plastic cage to prevent herbivory.

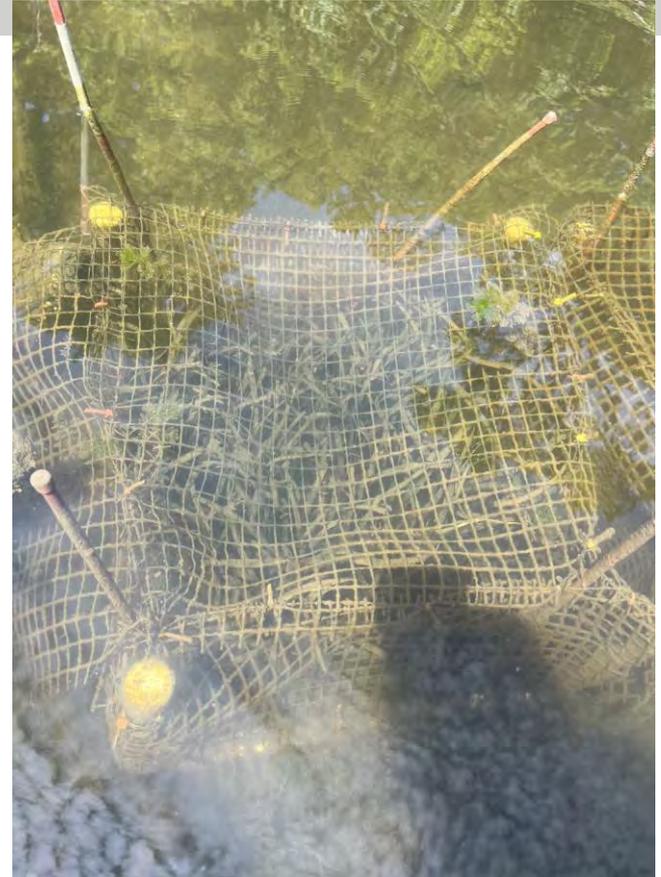
Restoration Methods 2025

- Empty "expansion cages" were placed close to each of the 3 plots to allow for protected expansion of native plants.

- Plants grew in the cages with plants added to them. No expansion was seen in the empty cages
- Invasive species also didn't grow in the empty cages.
