NYC Parks

Shoreline and shallow water enhancement in the New York Harbor

October 23, 2025

Ecological Assessment at 25 salt marshes across NYC

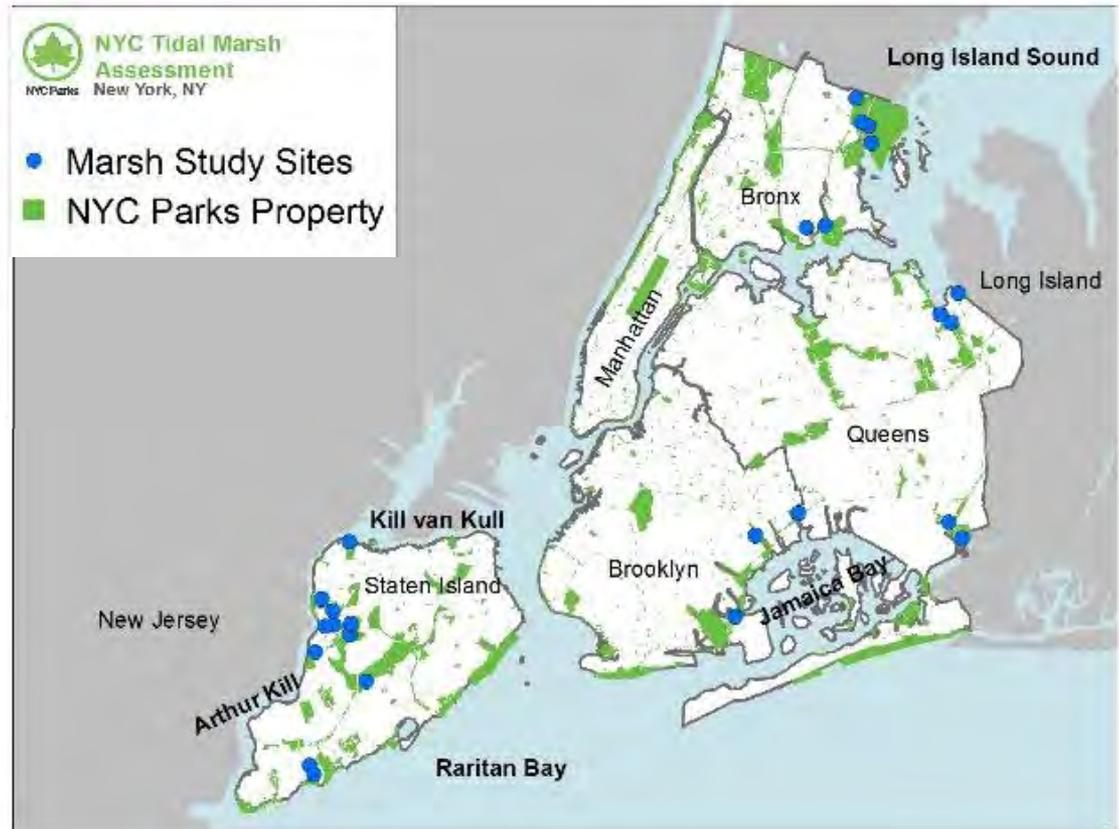
Conditions and vulnerability indices

Condition

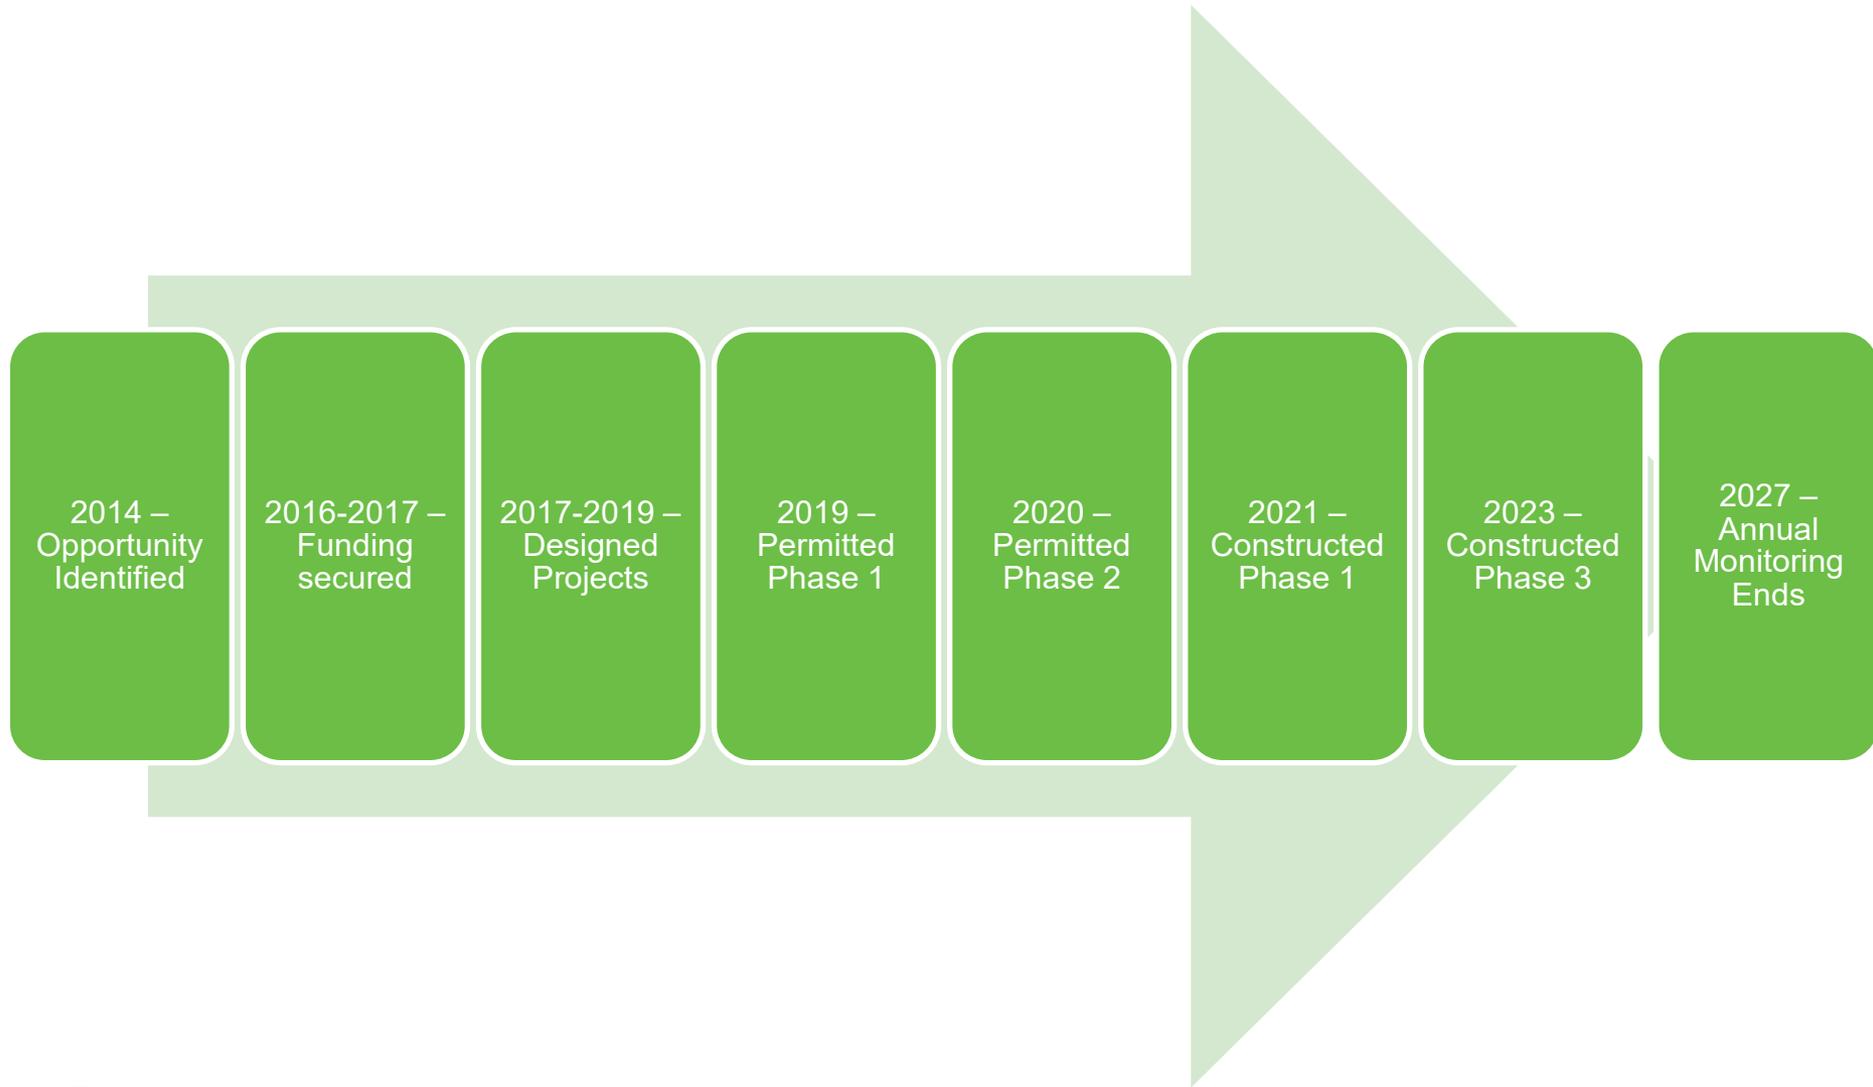
Project timeline

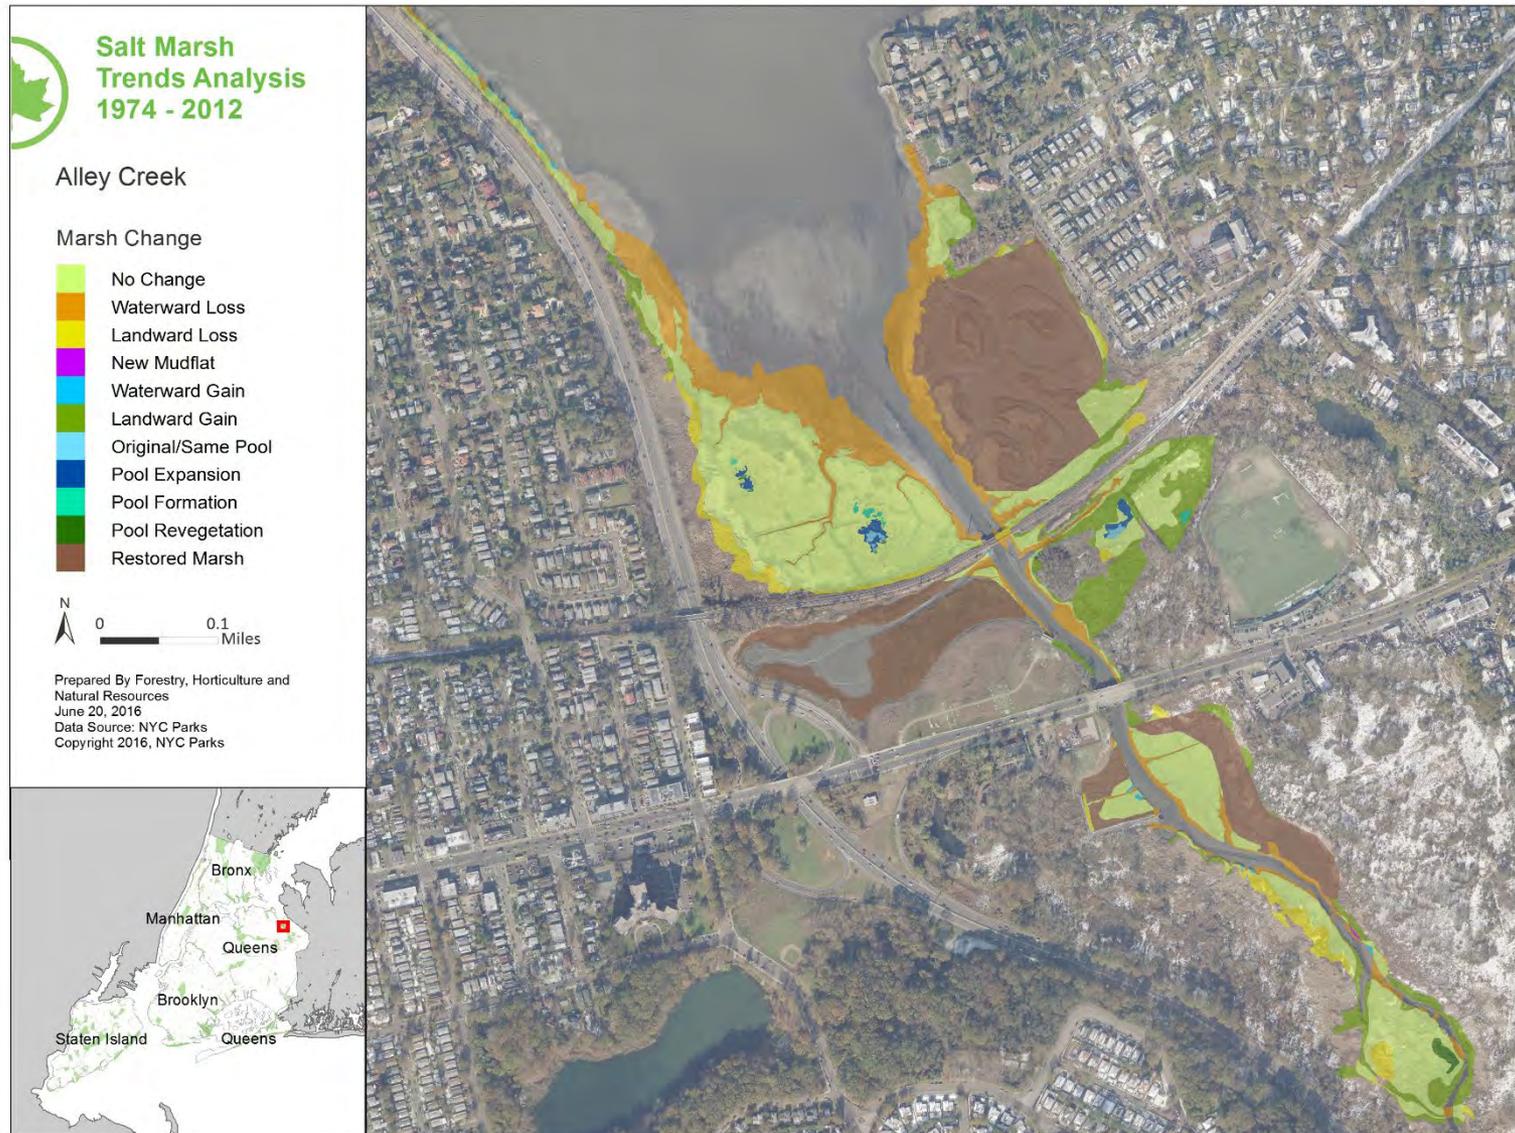
Trends analysis results (1974-2012 salt marsh area change)

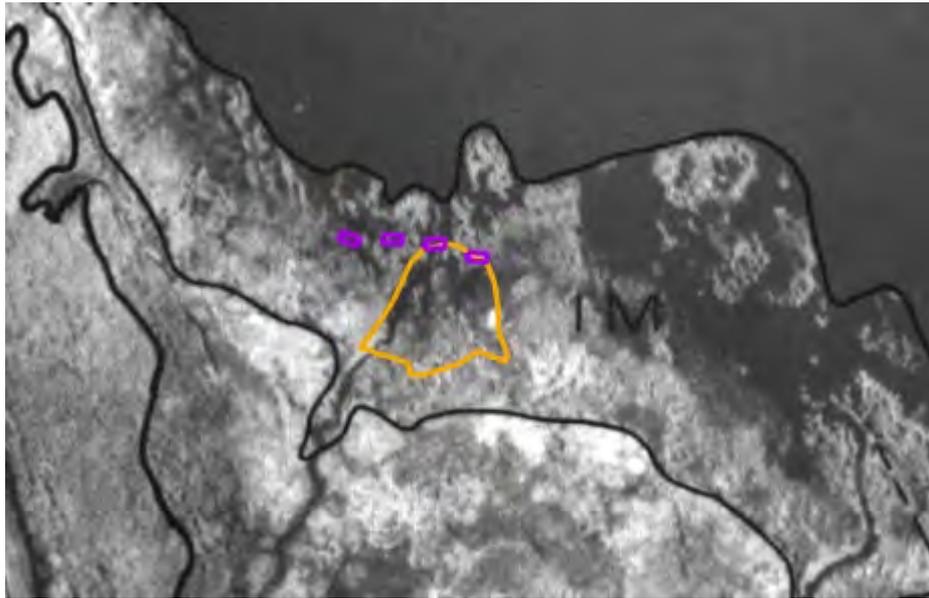
1974

Trends analysis results (1974-2012 salt marsh area change)

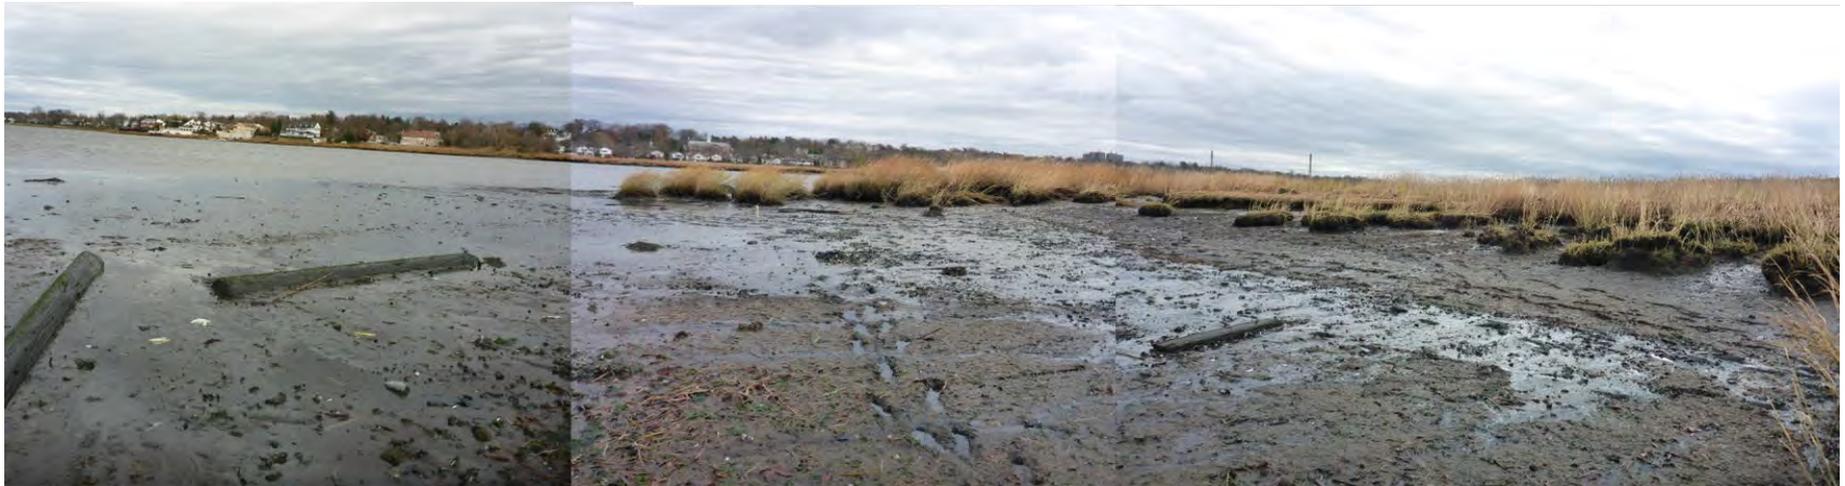
Oyster Castles

- Stabilize and prevent further erosion of existing marsh by dampening wave energy
- Create a protective structure with more ecological function than a breakwater or rock sill
- Provide a toe for the restored marsh
- Restore tidal elevations and re-establish eroded salt marsh

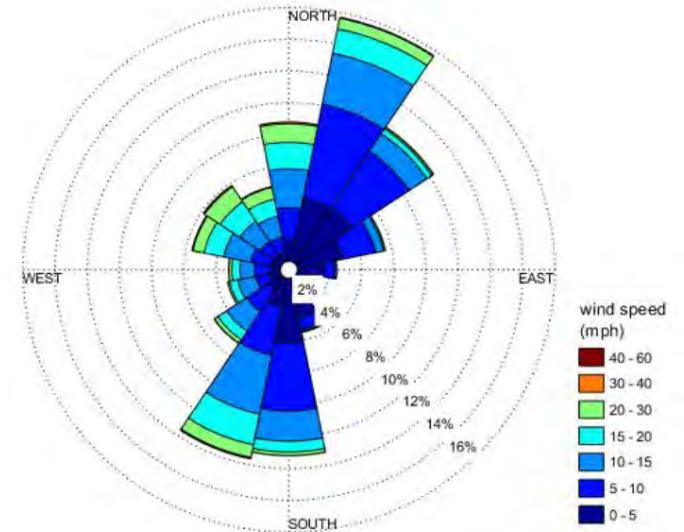
- Design wave height was 100-year joint probability windspeed from 330 degrees that results in a 1.0-2.6 feet wave height

Wind Rose, Annual, 2004-2018
NOAA Station KPTN6, King's Point, NY

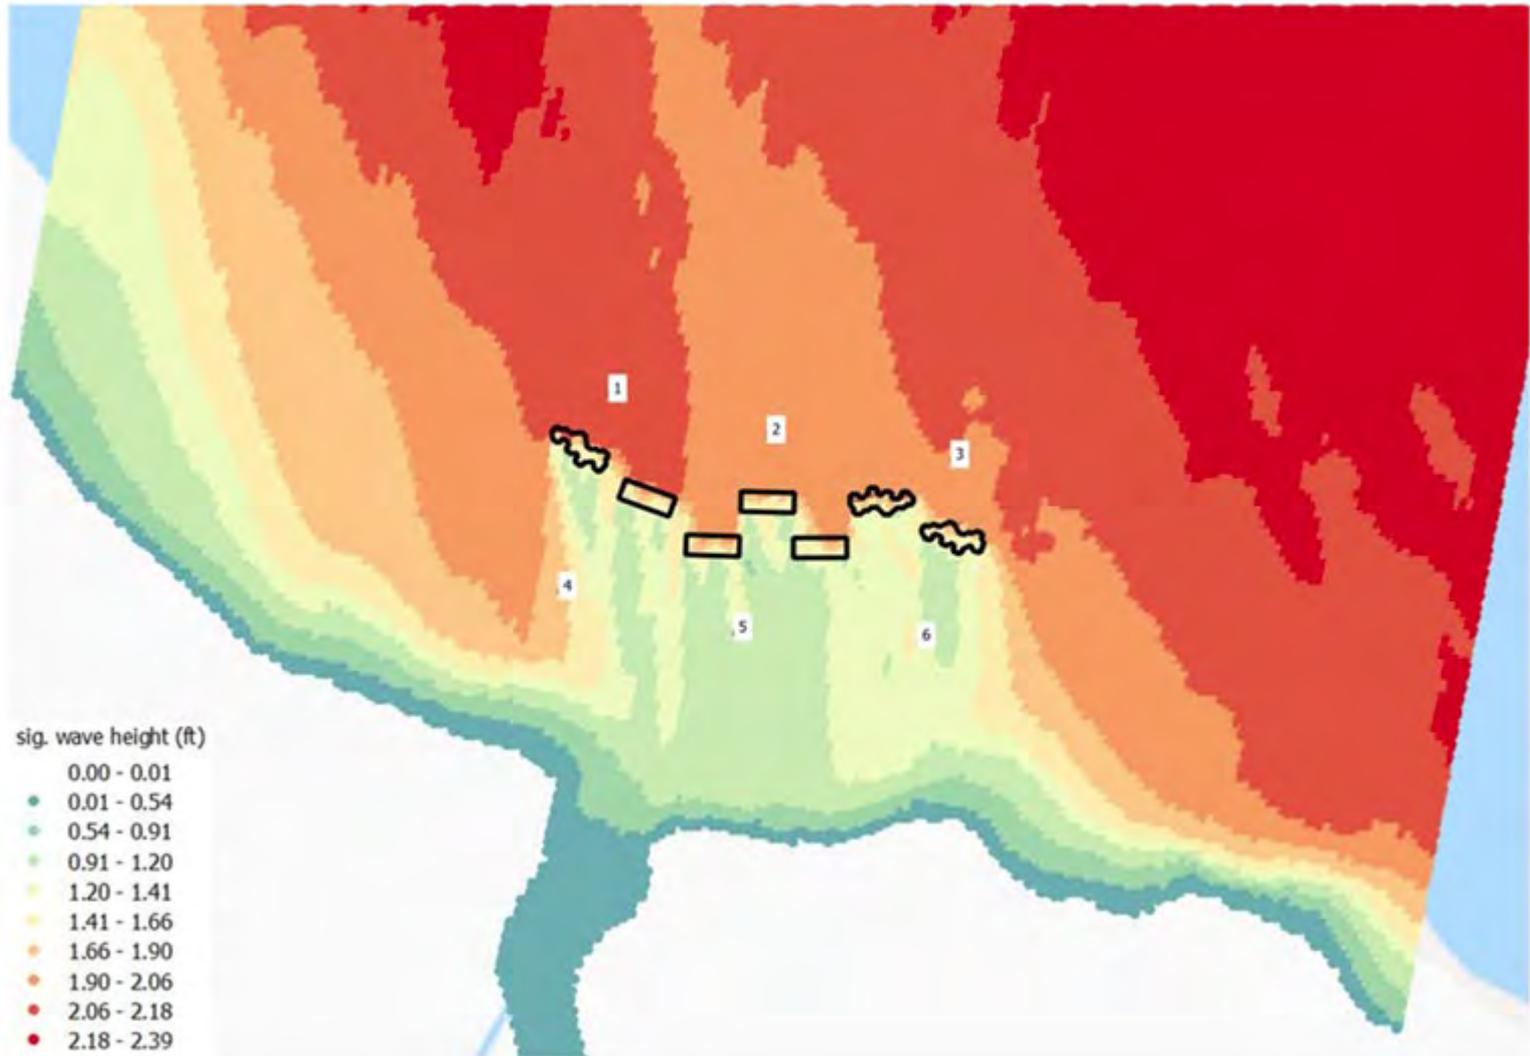
- Avoid a toe that armors the site around the full perimeter of the restoration
 - Wanted a lower impact toe
 - Allow for movement of horseshoe crabs and other wildlife
- Transplant some material and evaluate efficacy
- Sediment placement on existing marsh (particularly in between hummocks) is necessary to meet grade
- +++

Design considerations

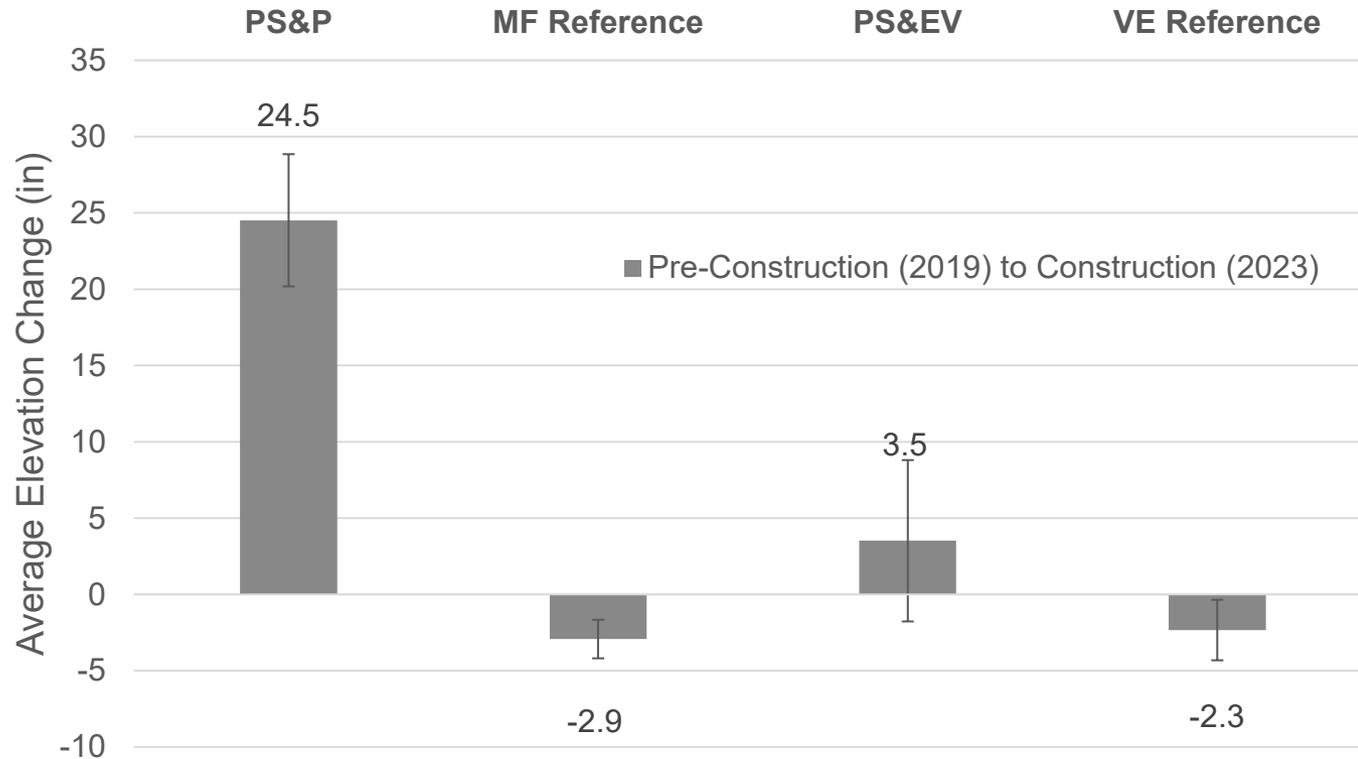
Post-construction sand placement results: 2019 to 2023

Average elevation change in inches by monitoring area from 2019 (pre-construction) to 2023 (year of construction). PS&P= Placed Sand and Planted, PS&EV= Placed Sand and Existing Vegetation, MF = mudflat, VE= Vegetated Edge.

- Post-construction, the elevation of the more waterward section of the site (placed sand and planted) increased by 24 inches while the landward section of the site (placed sand and existing vegetated edge) has increased by over three inches.
- Reference site elevation decreased slightly (~2-3 inches on average)

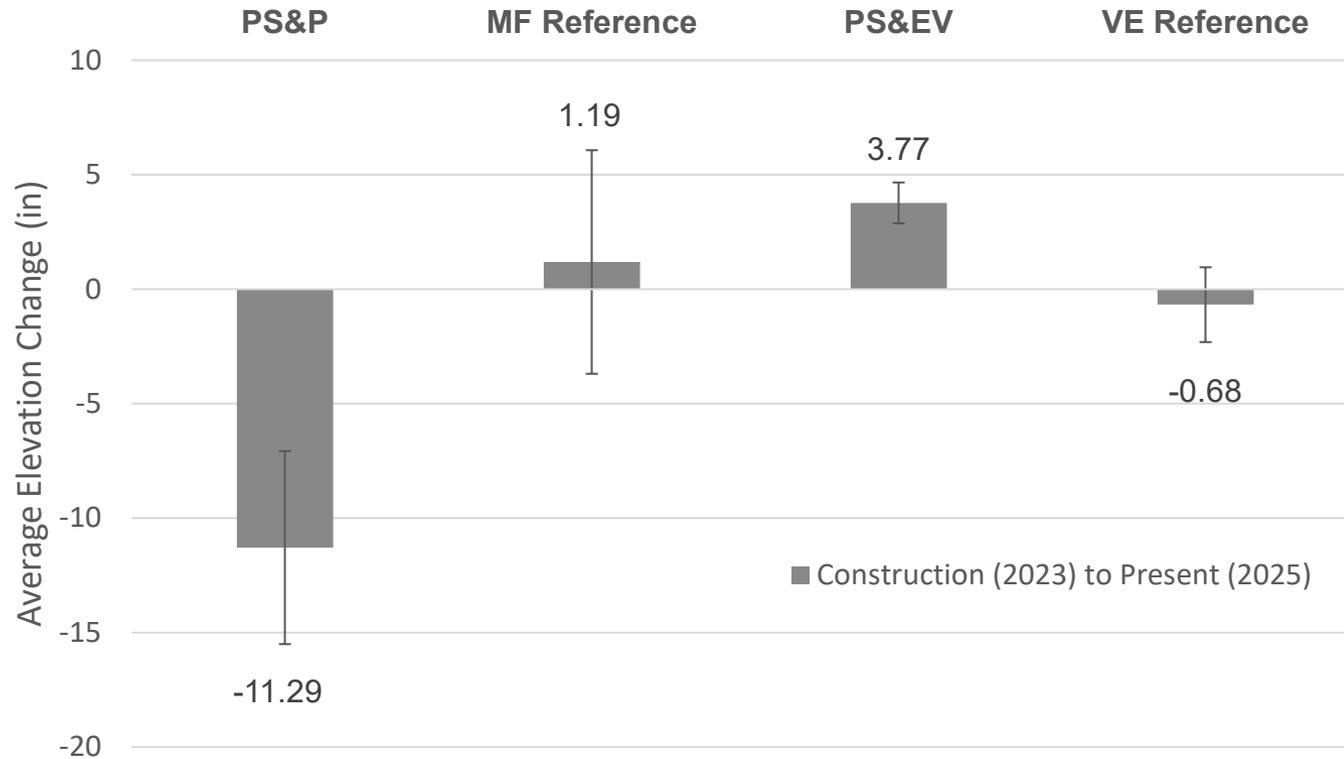
Post-construction sand placement results: 2023 to 2025

Average elevation change in inches by monitoring area from 2023 (year of construction) to 2025 (present). PS&P= Placed Sand and Planted, PS&EV= Placed Sand and Existing Vegetation, MF = mudflat, VE= Vegetated Edge.

- Post-construction, the elevation of the more waterward section of the site (placed sand and planted) has decreased by 11 inches while the landward section of the site (placed sand and existing vegetated edge) has increased by over three inches.
- Reference sites are generally stable (+/- 1 inch on average)

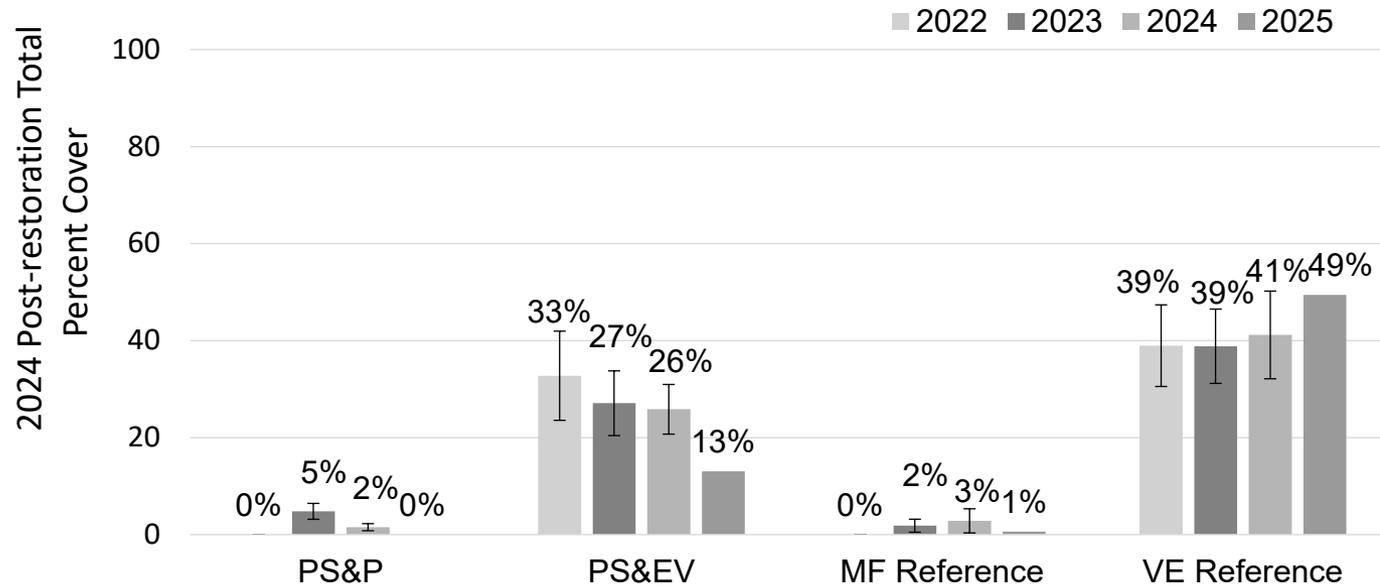
Post-construction sand placement results

- Vegetation cover remains higher in reference sites
- Vegetation cover is higher in sites with placed sand sites on existing vegetation vs sand placed on mudflat

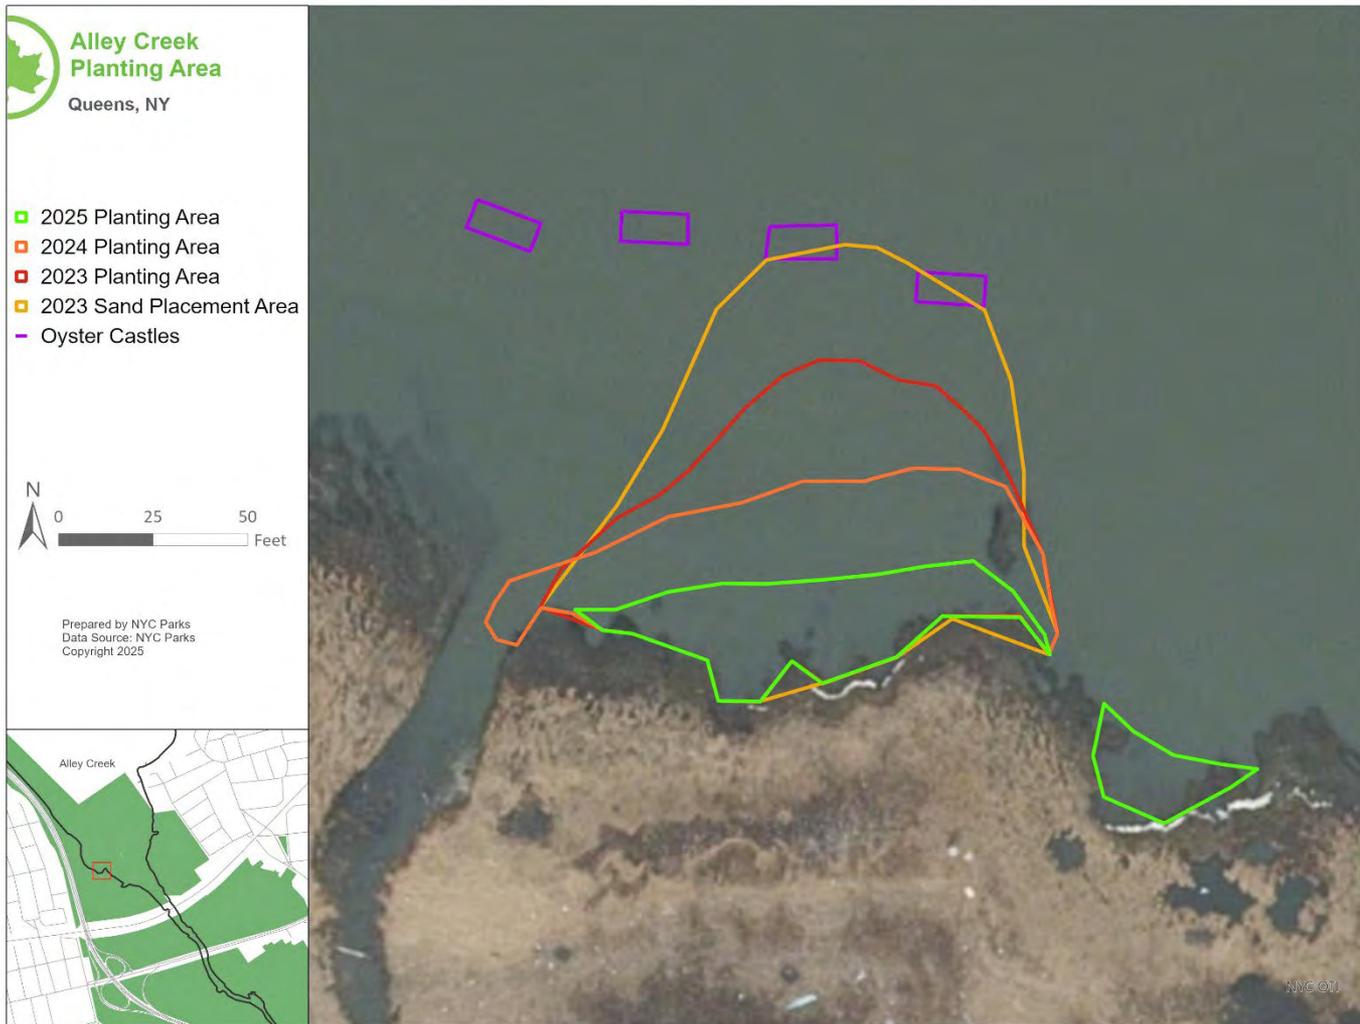
Post-construction sand placement results

- Planting area (above EI 0.5ft) shifting landward and long the shoreline
- Adaptive management – follow the sand and plant in higher areas – new planting areas along shoreline where sand has accumulated

- Maintain goose fence (if possible) – ice scour impacts fence in winter
- Follow sand – plant in new locations where sand had accumulated

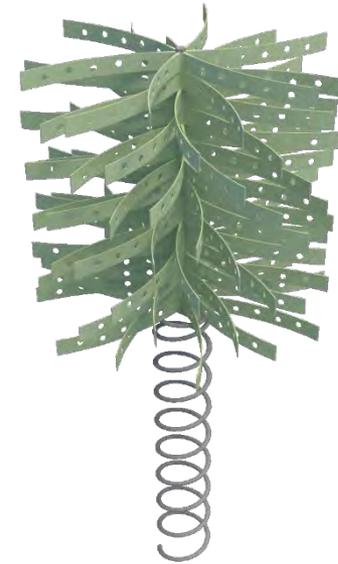
Marsh Guard from Coastal Technology Corp.

- Successful multi season plant establishment
- Experiment with Marsh Guards
- Experiment with Christmas tree fascines (used at West Pond in Jamaica Bay)

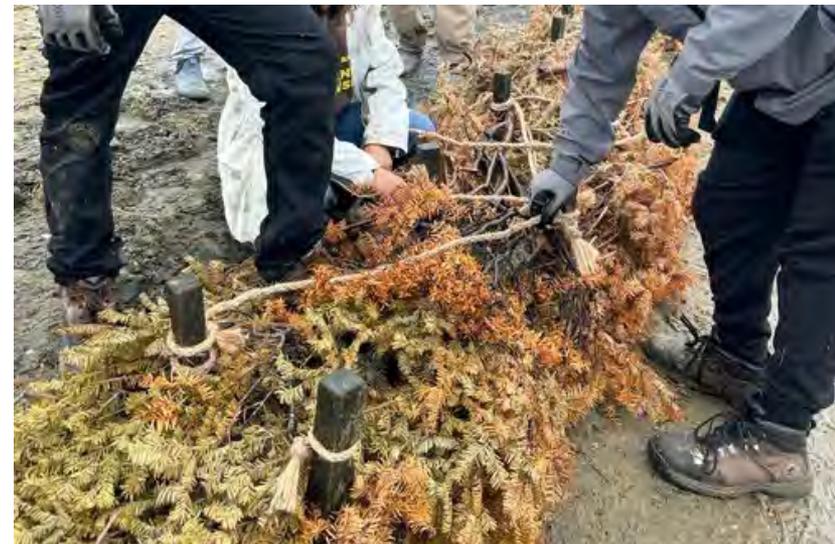
JBRPC Christmas tree fascines at West Pond in Jamaica Bay
